Evidence of Performance

Resistance to wind load

Test Report 106 33942e

Product/ Construction product	Balcony glazing with sliding side-hung casements
Designation	SF 25
Frame material	Aluminium EN AW-6063 T5
Special features	The test specimens were not openable.

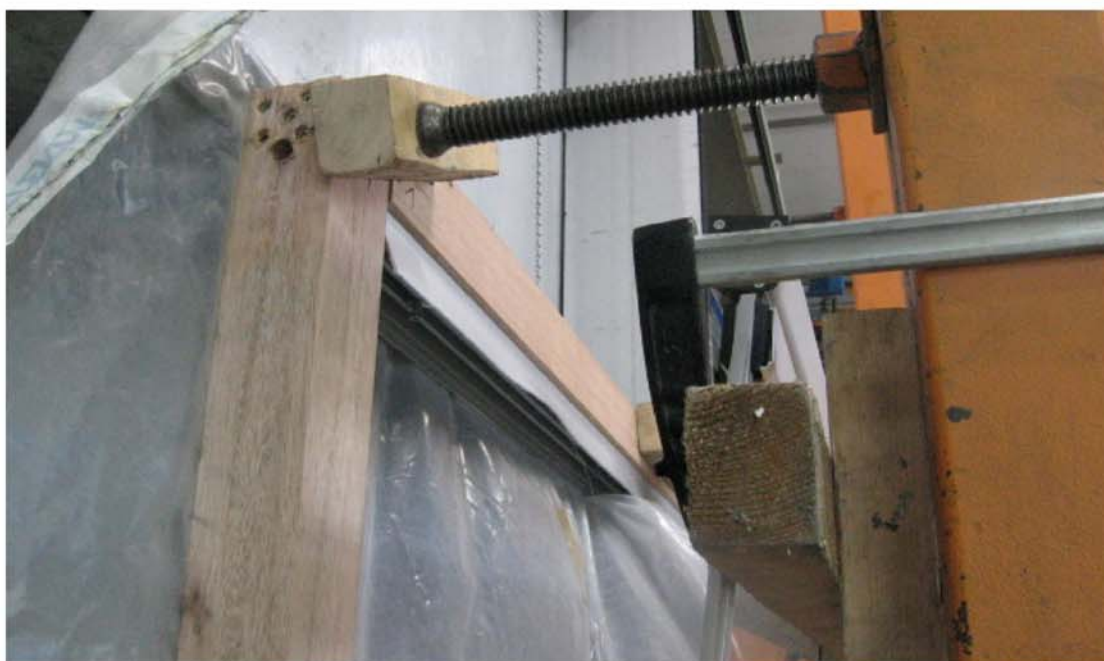
2000 Pa				no changes to the element, no measurement
2100 Pa				no changes to the element, no measurement
2200 Pa				no changes to the element, no measurement
2300 Pa				Unit is drawn out completely from height compensation profile at top; height compensation profile deformed; no glass breakage

Fig. 1 Top rail drawn out from height compensation profile at 2300 Pa, height compensation profile deformed.

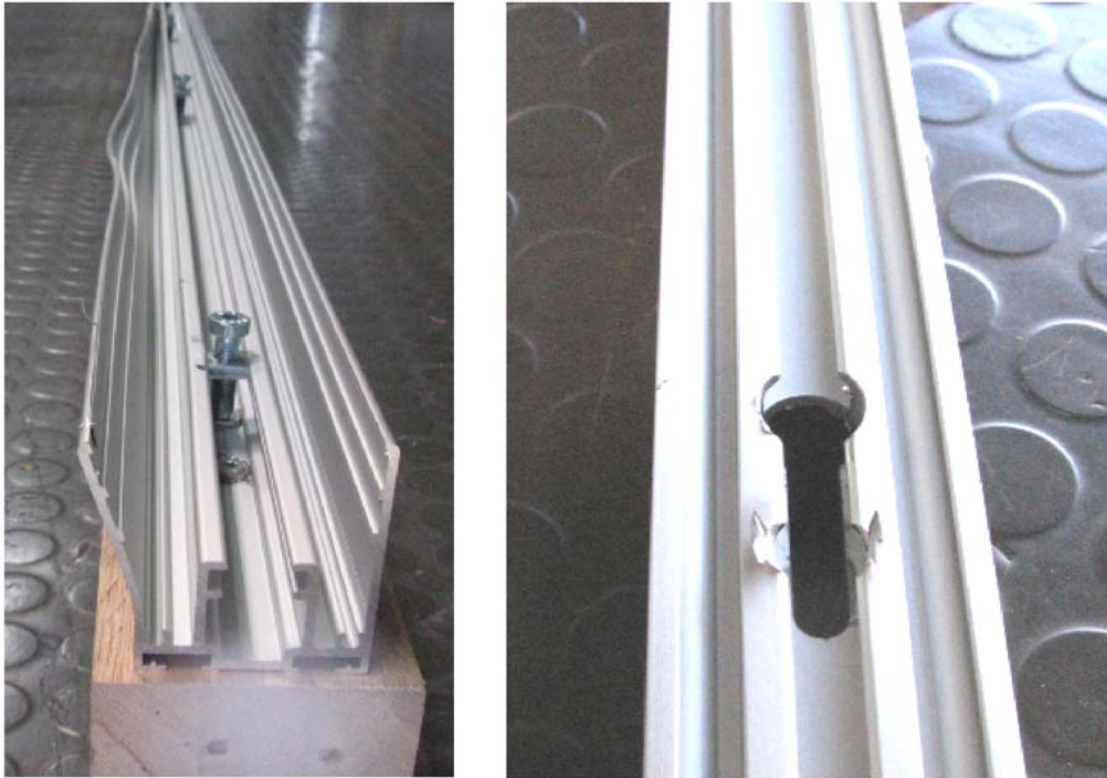
Fig. 2 and 3 Cause of failure, aluminium profile torn out around screw heads

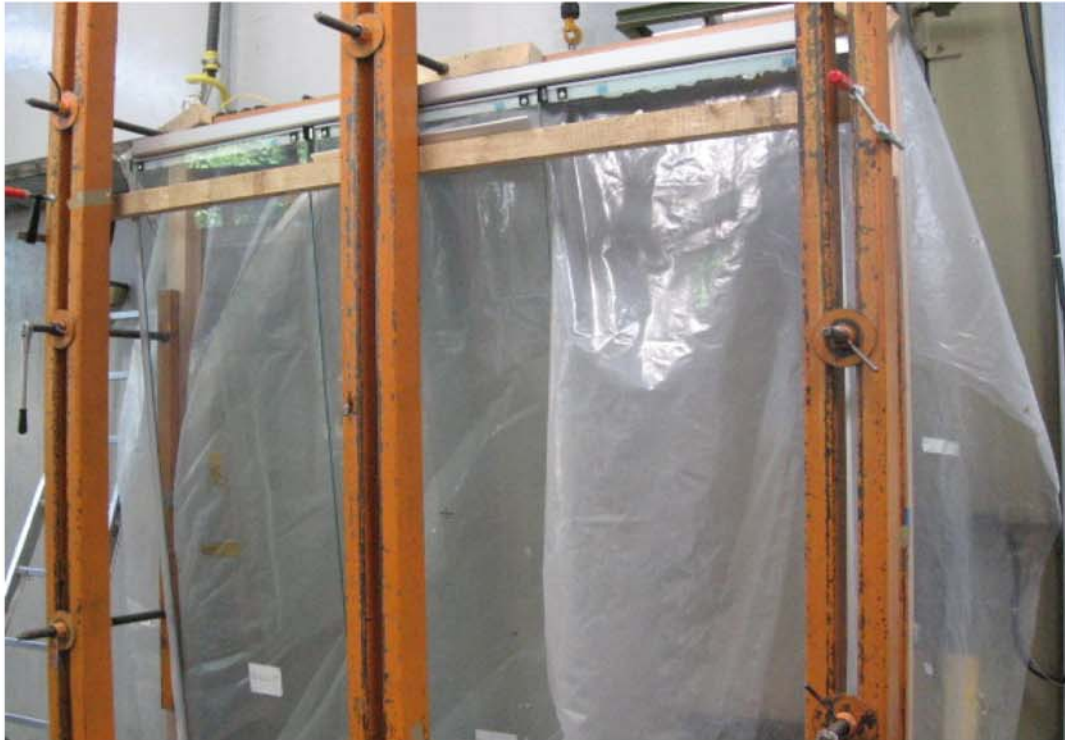
3800	Pa				no changes to the element, no measurement
3900	Pa				no changes to the element, no measurement
4000	Pa				Unit jumps out at top from height compensation profile; right-hand pane breaks when hitting the timber block; height compensation profile deformed;

Fig. 1 Top rail drawn out from height compensation profile at 4000 Pa, height compensation profile deformed, right-hand pane broken when hitting the test rig, cover sections disengaged.

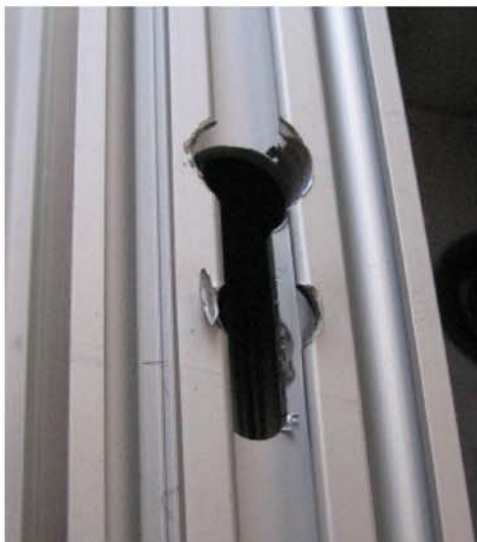
Fig. 2 Cause of failure, break-outs at Aluminium profile around screws.

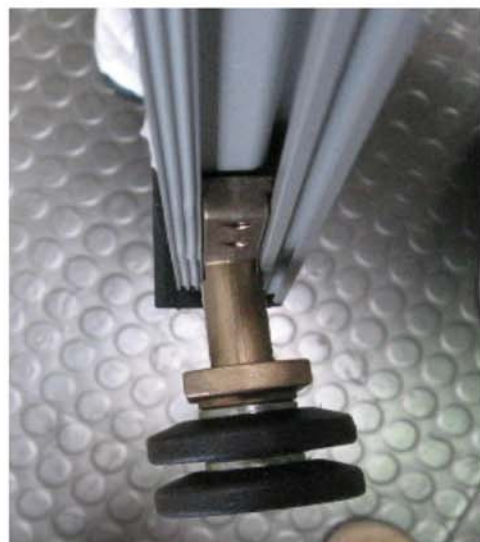
Fig. 3 Guide runners permanently deformed
